Architectural Survey at Joint Base Langley-Eustis of Fort Eustis Buildings and Structures Built 1946–1975: Volume II (Inventory Forms)

Sunny E. Adams and Adam D. Smith

December 2015

Final report

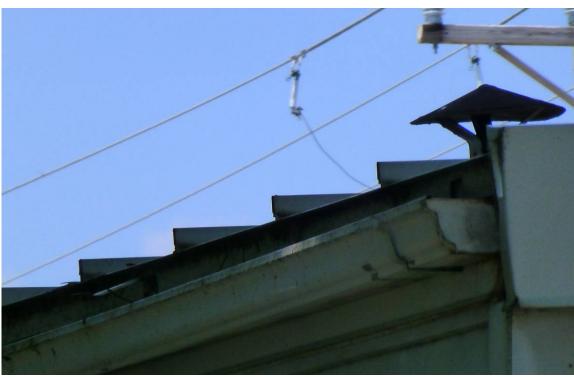
Photo 7. Building 670, close-up of the metal channel roofing material (ERDC-CERL, 2014).

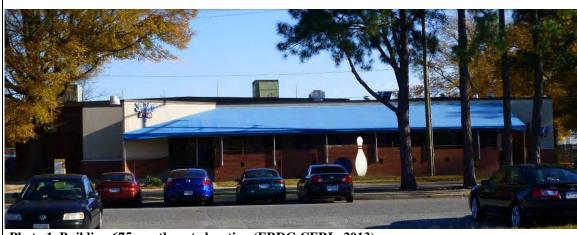
Photo 1. Building 675, northwest elevation (ERDC-CERL, 2013).

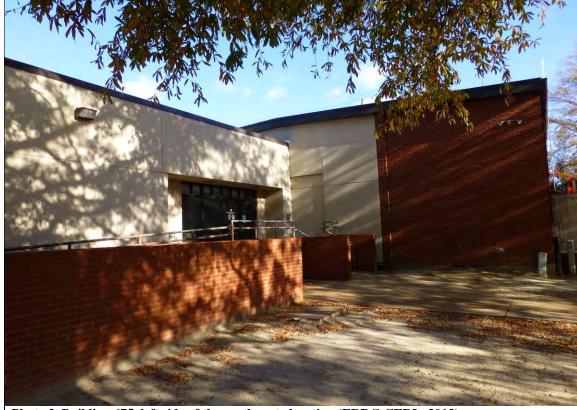
Photo 2. Building 675, left side of the southwest elevation (ERDC-CERL, 2013).

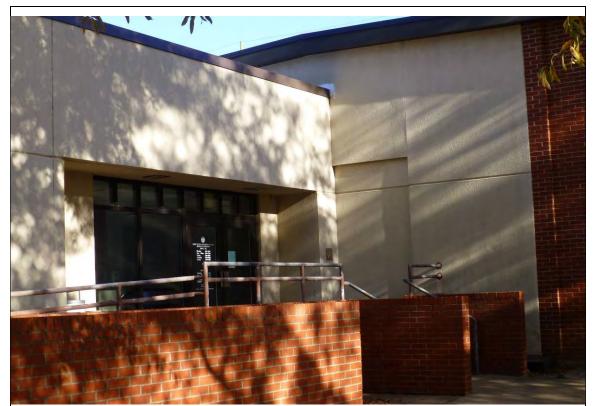
Photo 3. Building 675, close-up of the modified exterior of the left side of the southwest elevation (ERDC-CERL, 2013).

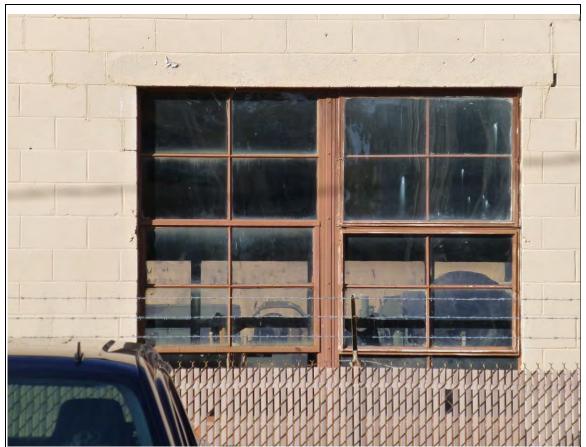
Photo 2. Building 806, close-up of original steel multipane awning industrial windows on the east elevation (ERDC-CERL, 2013).

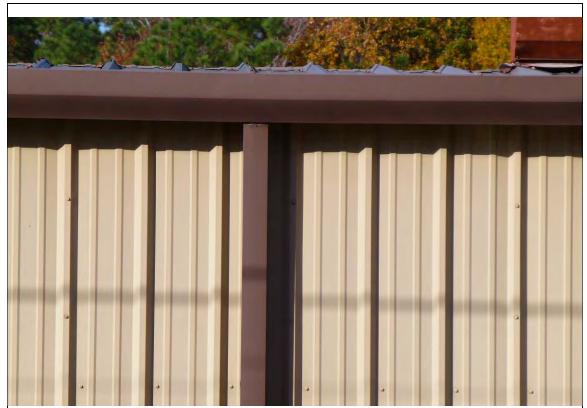
Photo 3. Building 821, close-up of modified exterior cladding (ERDC-CERL, 2013).

Building 821 was constructed in 1964 as an administration building for the 800 motor pool area. The majority of the original construction materials have been removed and replaced with newer materials (metal siding, replacement metal windows, replacement entry doors, and replacement metal roof).

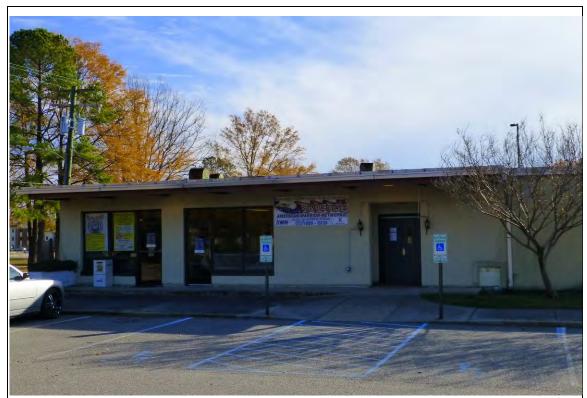
Photo 3. Building 824, close-up of the modified main entry with replacement anodized-bronze aluminum and plate-glass doors and windows on the left side of the west elevation (ERDC-CERL, 2013).

At an unknown date(s), the original exterior walls were modified with a stucco-like cladding material, the original windows have been removed and replaced, and the original doors have been replaced.

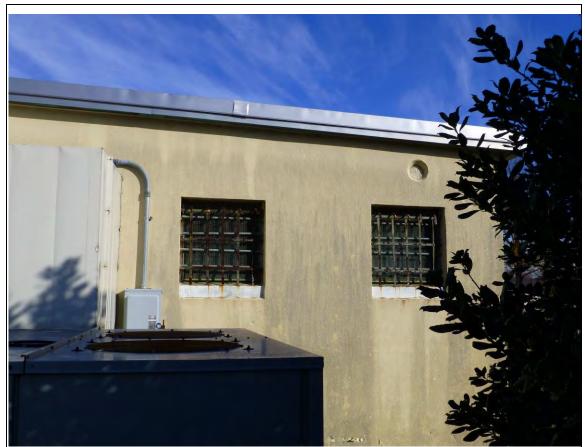
Photo 5. Building 824, close-up of original windows with metal security grates on the right side of the south elevation (ERDC-CERL, 2013).

The south elevation has a single-entry replacement metal door, a set of replacement metal doors, and two small square windows. The windows are located on the right side of the elevation, and each have a metal security grate covering them.

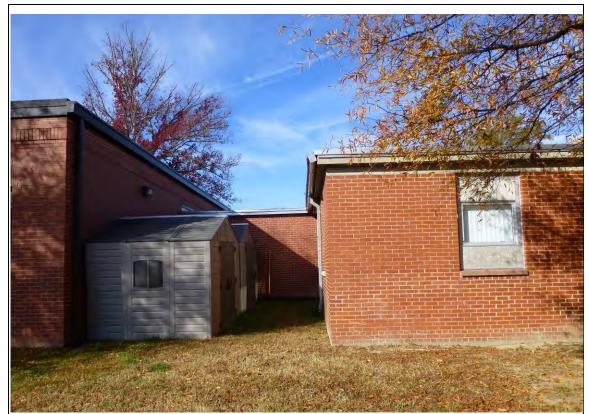
Photo 5. Building 826, brick hyphen on the east elevation connecting original part of the building on the right side to the addition on the left side (ERDC-CERL, 2013).

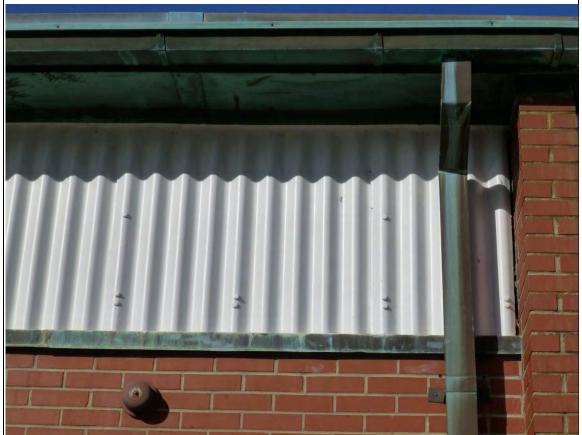
Photo 2. Building 829, close-up of modified window opening on the top portion of the east elevation (ERDC-CERL, 2013).

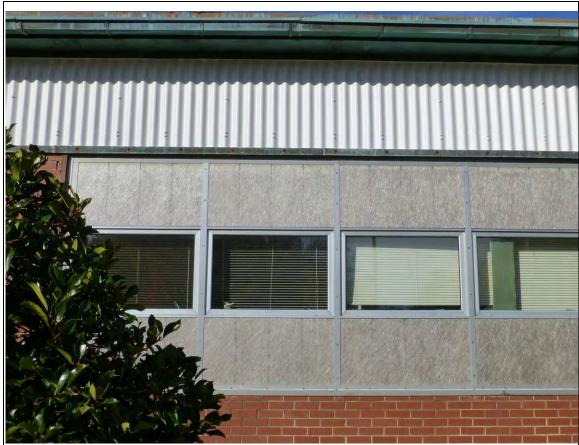
Photo 6. Building 829, close-up of modified window openings on the east elevation (ERDC-CERL, 2013).

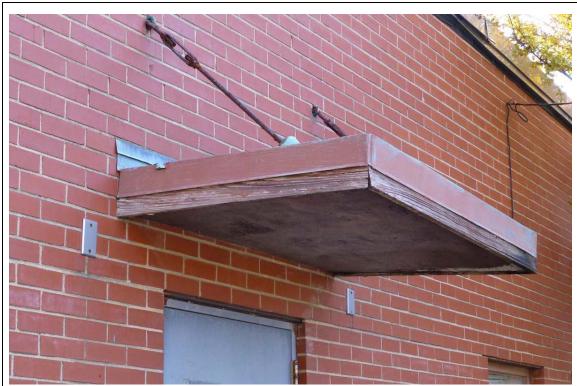
Photo 3. Building 830, close-up of canopy structure above entry door on the west elevation (ERDC-CERL, 2013).

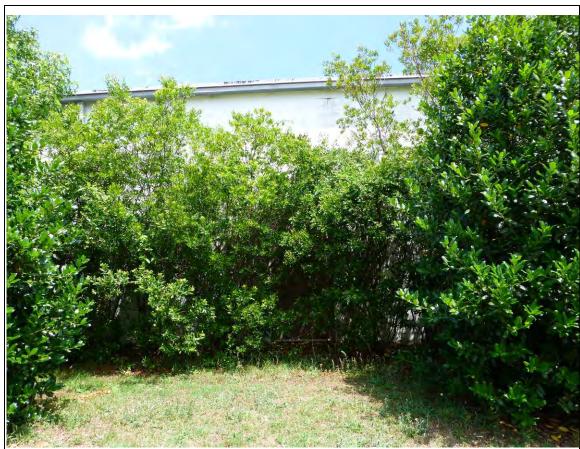
Photo 2. Building 832, door hidden behind the vegetation on the west elevation (ERDC-CERL, 2014).

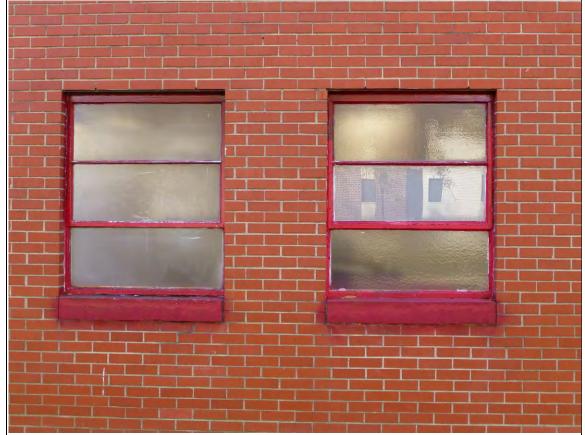
Photo 6. Building 833, close-up of original steel awning windows located on the north elevation (ERDC-CERL, 2013).

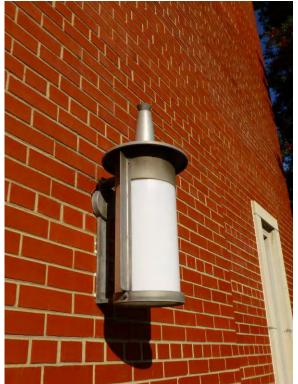
Photo 4. Building 923, original light fixture located near the main entry on the south elevation (ERDC-CERL, 2013).

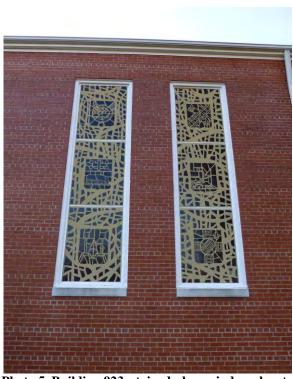
Photo 5. Building 923, stained-glass windows located on the east elevation of the nave portion of the building (ERDC-CERL, 2013).

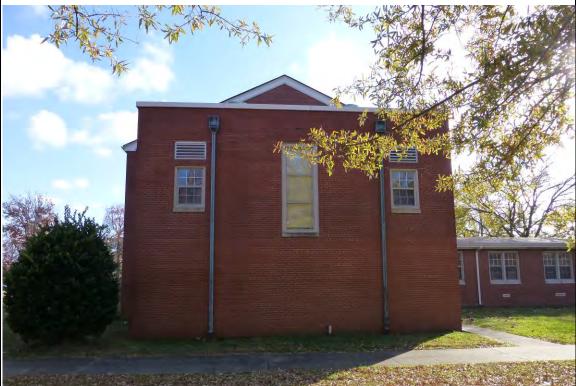
Photo 6. Building 923, left side (back side of the chapel space) of the north elevation (ERDC-CERL, 2013).

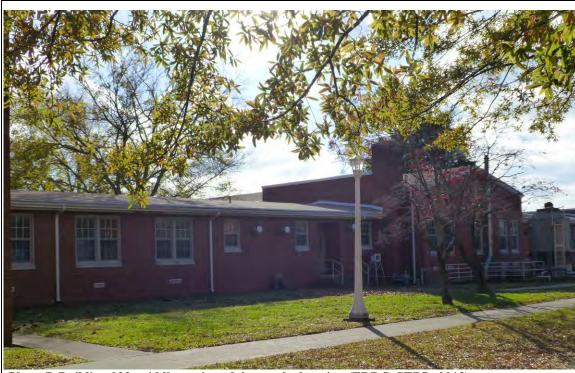
Photo 7. Building 923, middle section of the north elevation (ERDC-CERL, 2013).

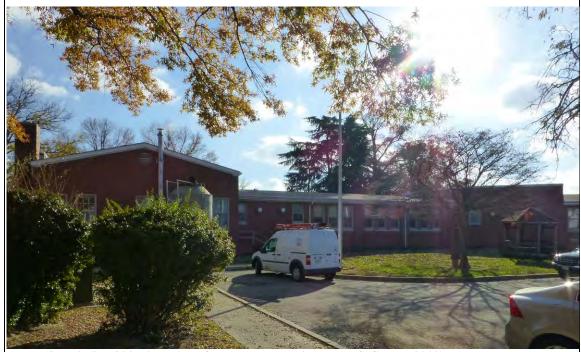
Photo 8. Building 923, right side of the north elevation (ERDC-CERL, 2013).

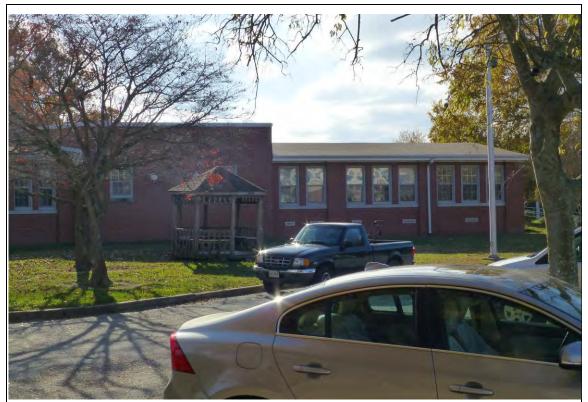
Photo 9. Building 923, northeast elevation of the right side of the back elevation (ERDC-CERL, 2013).

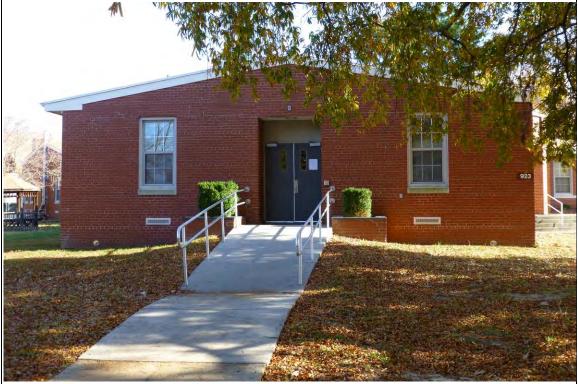
Photo 10. Building 923, northwest elevation of the west wing (ERDC-CERL, 2013).

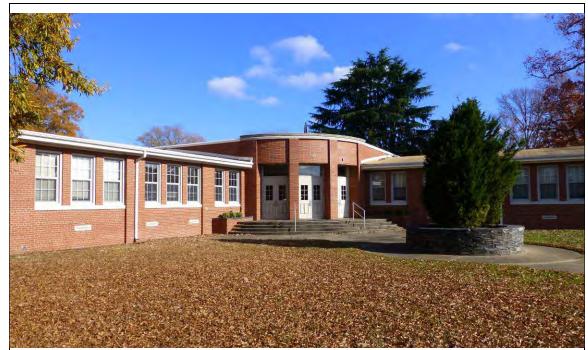
Photo 11. Building 923, entry into the addition off the west side of the building (ERDC-CERL, 2013).

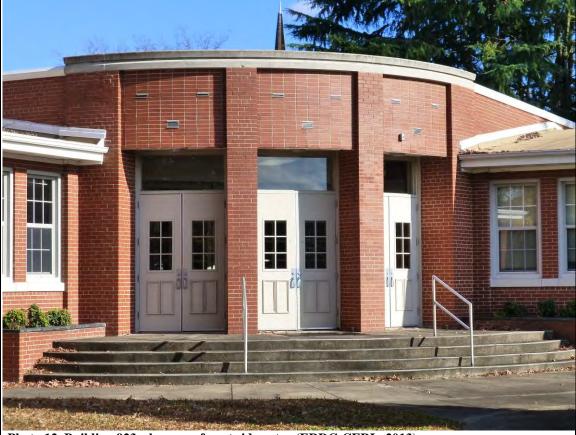
Photo 12. Building 923, close-up of west side entry (ERDC-CERL, 2013).

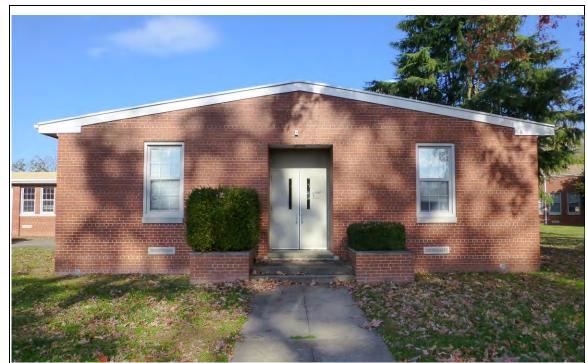
Photo 13. Building 923, southwest elevation of the west wing (ERDC-CERL, 2013).

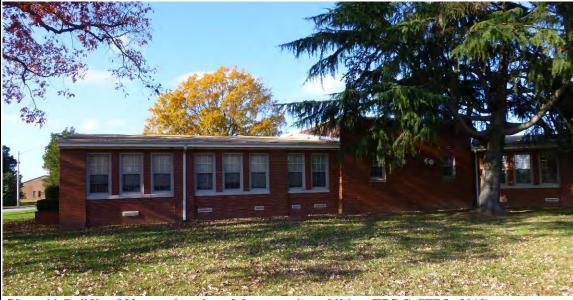
Photo 14. Building 923, east elevation of the west wing addition (ERDC-CERL, 2013).

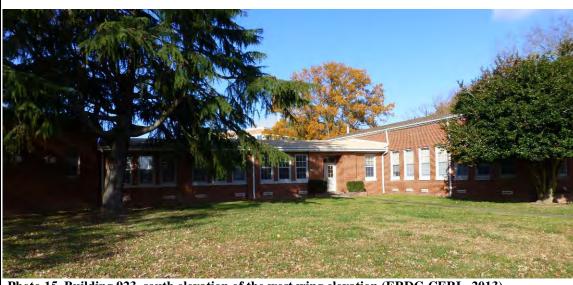
Photo 15. Building 923, south elevation of the west wing elevation (ERDC-CERL, 2013).

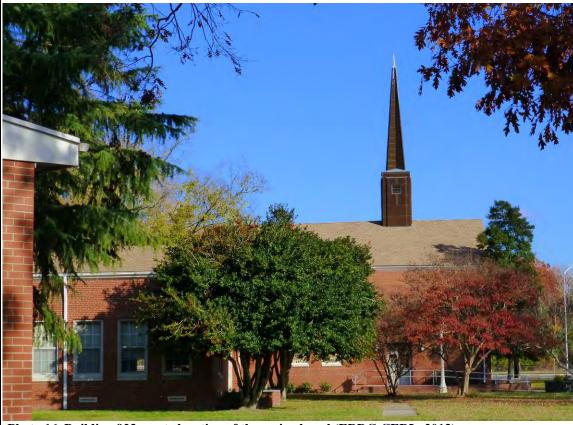
Photo 16. Building 923, west elevation of the main chapel (ERDC-CERL, 2013).

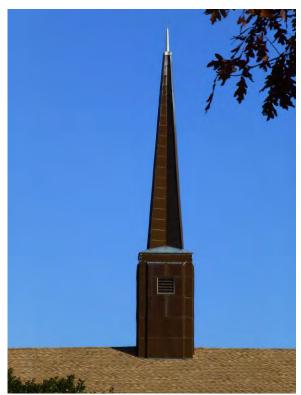
Photo 17. Building 923, copper-clad steeple (ERDC-CERL, 2013).

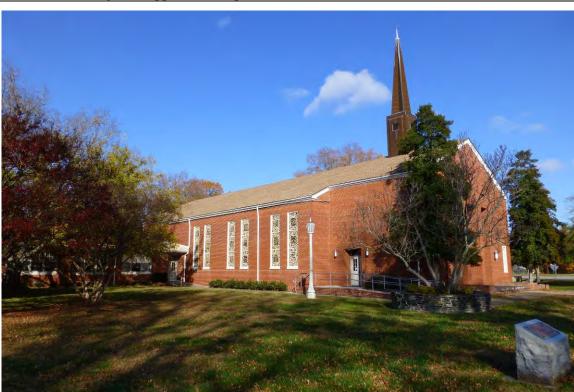
Photo 18. Building 923, southwest oblique of the main chapel (ERDC-CERL, 2013).

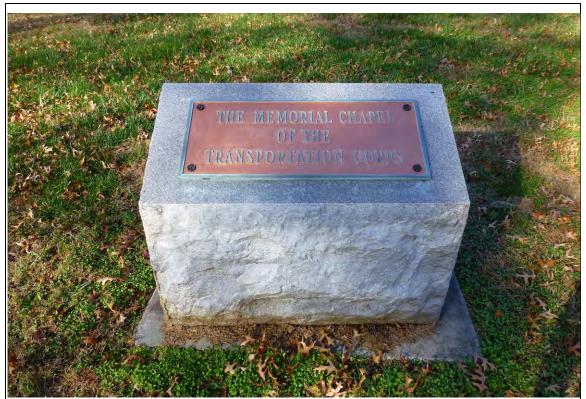
Photo 19. Building 923, plaque located to the south of the main chapel entry (ERDC-CERL, 2013).

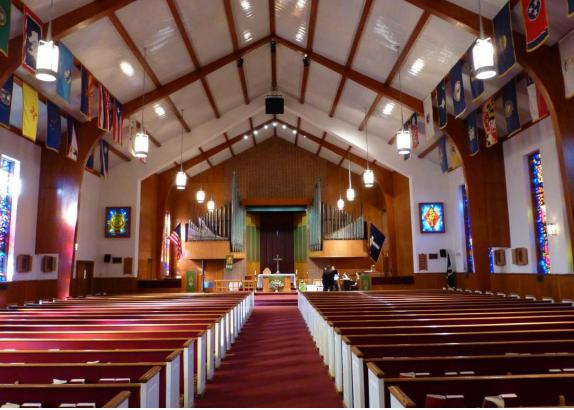
Photo 20. Building 923, interior of the nave, looking north at the altar (ERDC-CERL, 2013).

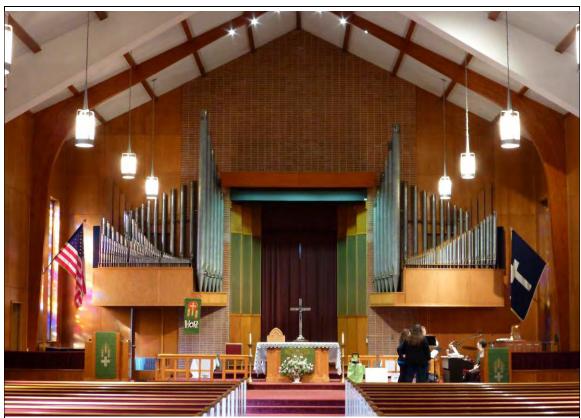
Photo 21. Building 923, looking north at the altar (ERDC-CERL, 2013).

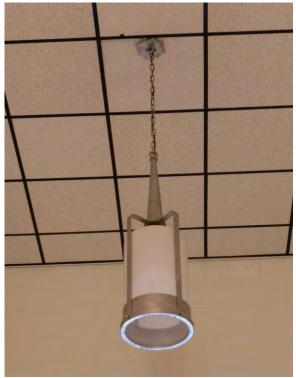
Photo 22. Building 923, original pendent light fixture hanging from nave ceiling (ERDC-CERL, 2013).

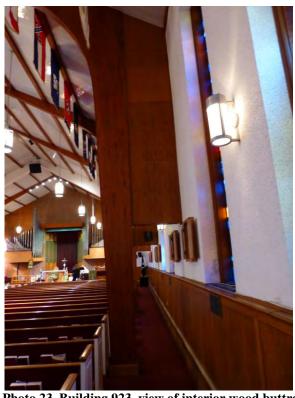
Photo 23. Building 923, view of interior wood buttresses and wall sconce (ERDC-CERL, 2013).

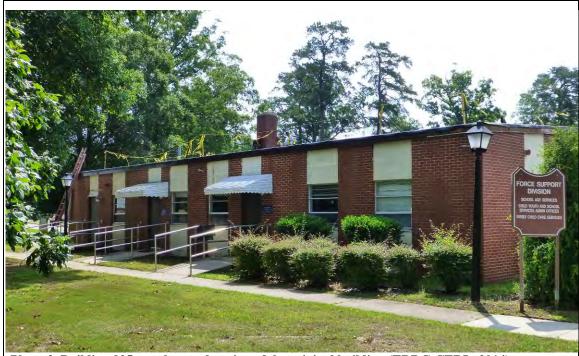
Photo 2. Building 925, northwest elevation of the original building (ERDC-CERL, 2014).

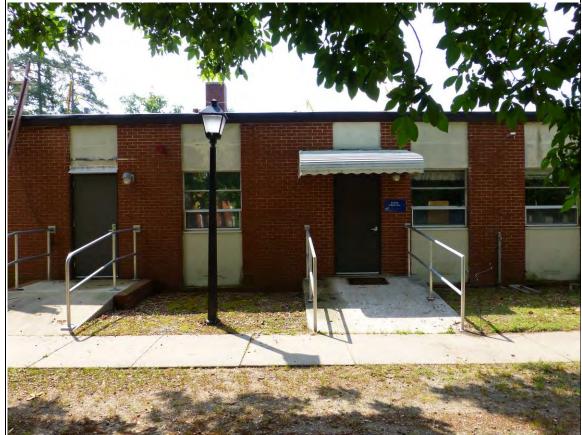
Photo 3. Building 925, close-up of windows and doors and modified concrete ramp accessibility on the northwest elevation of the original building (ERDC-CERL, 2014).

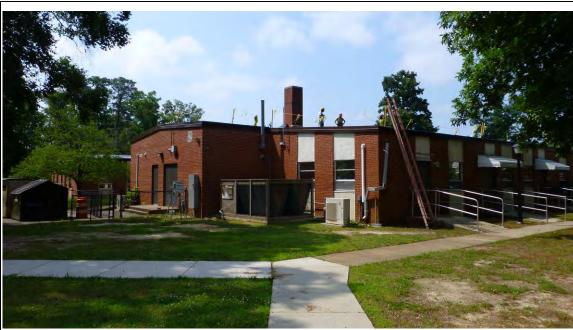
Photo 4. Building 925, north corner of the original building (ERDC-CERL, 2014).

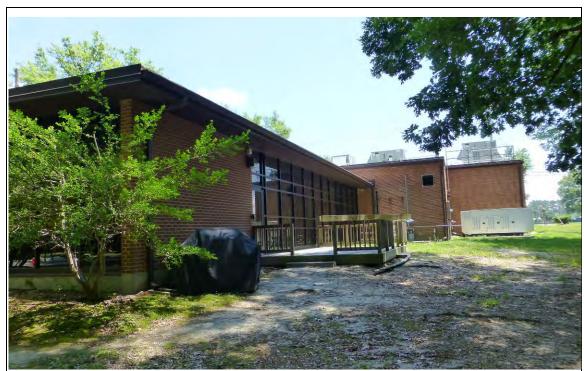
Photo 2. Building 1013, southeast elevation (ERDC-CERL, 2014).

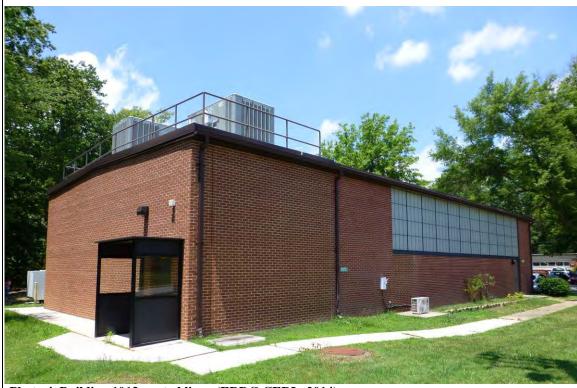
Photo 4. Building 1013, east oblique (ERDC-CERL, 2014).

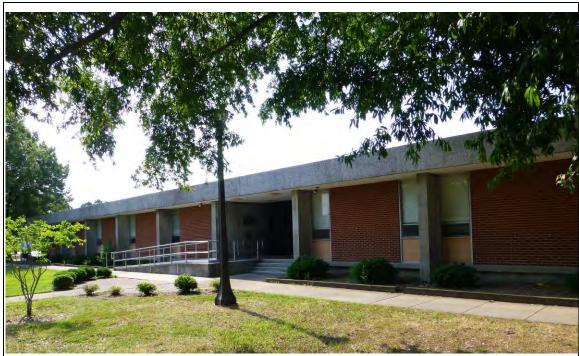
Photo 1. Building 1313, north elevation (ERDC-CERL, 2014).

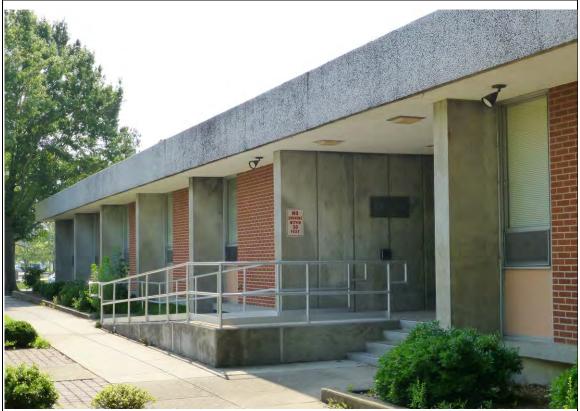
Photo 2. Building 1313, main entry on the north elevation with ADA ramp addition (ERDC-CERL, 2014).

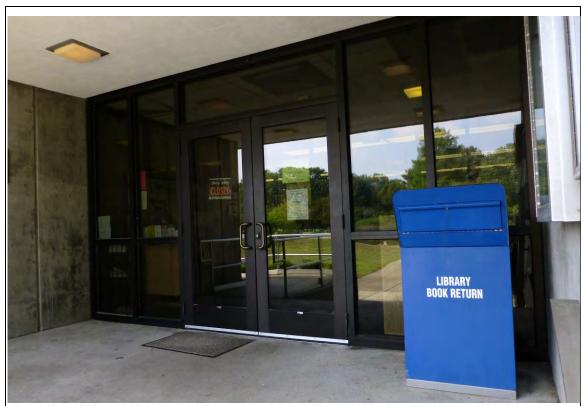
Photo 3. Building 1313, close-up of replacement anodized-bronze aluminum plate-glass doors, sidelights, and transom on the main entry on the north elevation (ERDC-CERL, 2014).

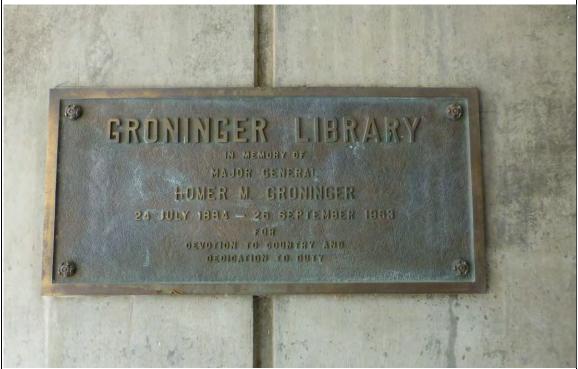
Photo 4. Building 1313, bronze plaque placed on the concrete wall of the recessed entry on the north elevation (ERDC-CERL, 2014).

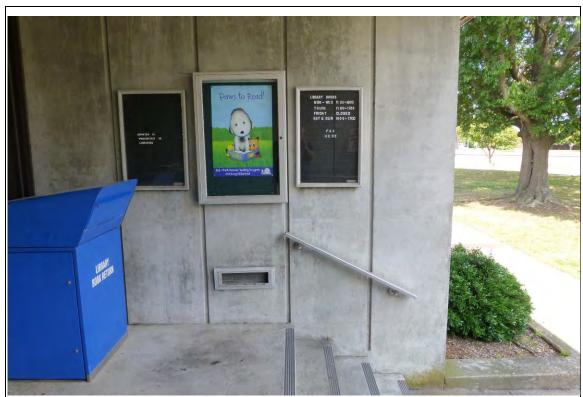
Photo 5. Building 1313, poured-in-place concrete wall of the recessed entry on the north elevation (ERDC-CERL, 2014).

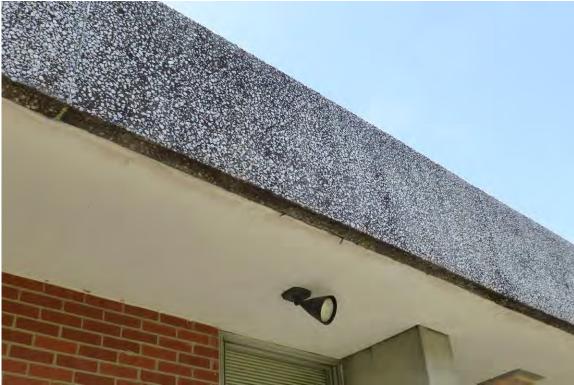
Photo 6. Building 1313, overhang that encompasses the entire building, faced with aggregate concrete (ERDC-CERL, 2014).

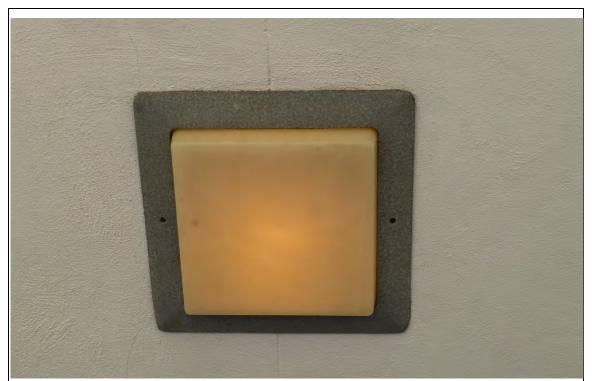
Photo 7. Building 1313, original light fixture located on the underside of the recessed entry on the north elevation (ERDC-CERL, 2014).

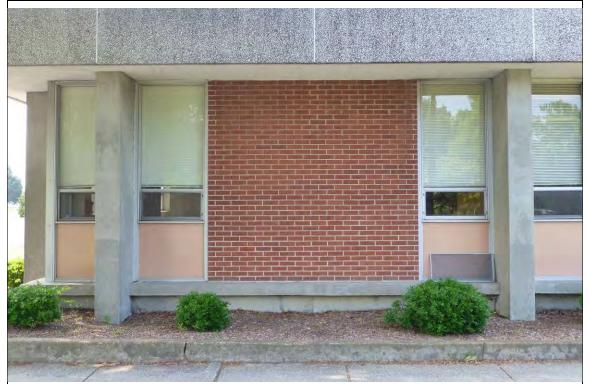
Photo 8 Building 1313, left side of north elevation showing bay detail with brick veneer wall, concrete buttresses, concrete watertable, and bright-aluminum and panel windows (ERDC-CERL, 2014).

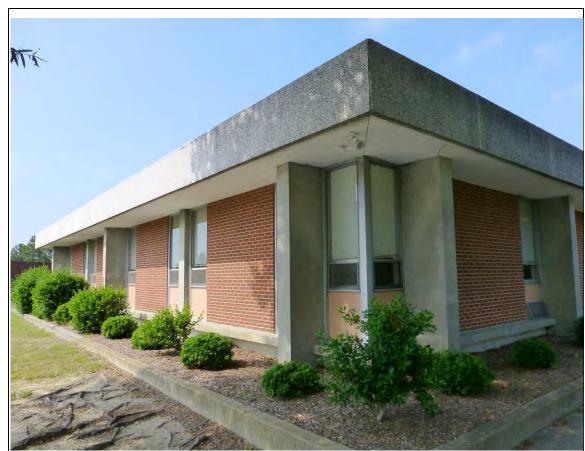
Photo 9. Building 1313, northeast oblique corner detail with corner window framed by concrete buttresses (ERDC-CERL, 2014).

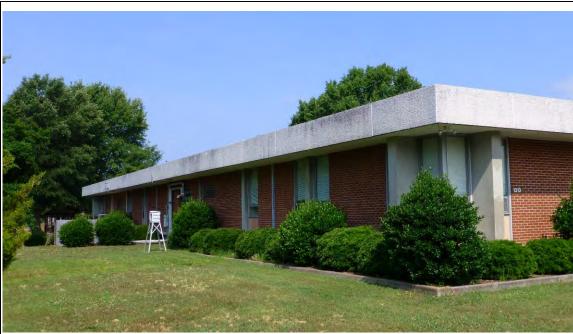
Photo 11. Building 1313, southeast oblique (ERDC-CERL, 2014).

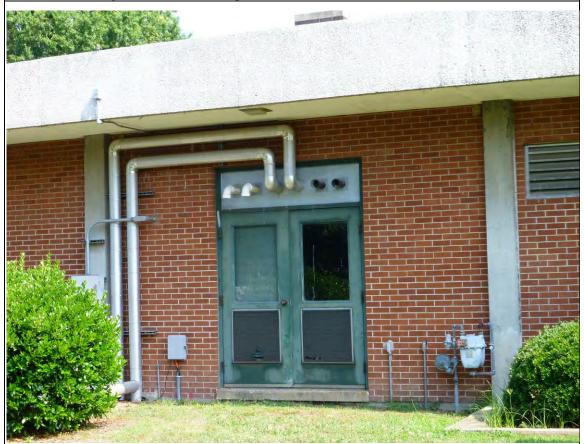
Photo 12. Building 1313, original metal service doors located on the south elevation (ERDC-CERL, 2014).

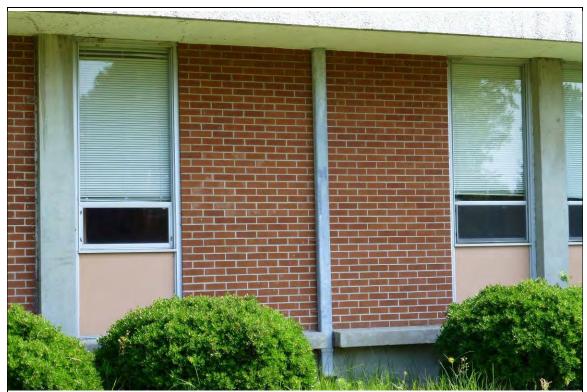
Photo 13. Building 1313, bay detail with brick veneer wall, concrete buttresses, concrete watertable, and bright-aluminum and panel windows on the south elevation (ERDC-CERL, 2014).

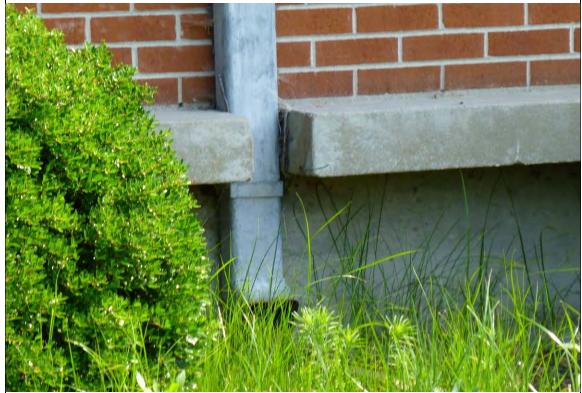
Photo 14. Building 1313, close-up of downspout detail on the south elevation (ERDC-CERL, 2014).

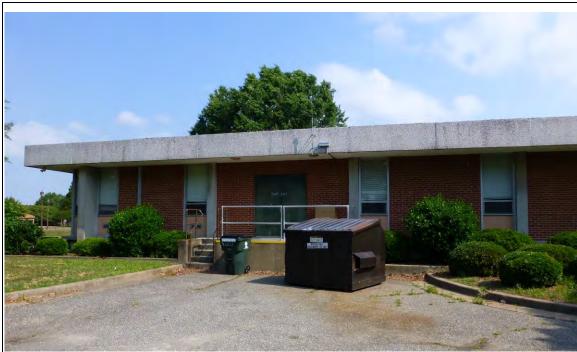
Photo 15. Building 1313, raised concrete loading dock area located on the left side of the south elevation (ERDC-CERL, 2014).

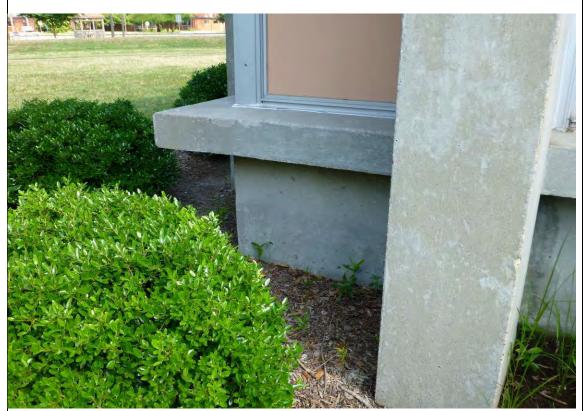
Photo 16. Building 1313, close-up of the corner detail with the concrete watertable and ledge, the bright-aluminum and panel window, and the concrete buttress, located on the southwest corner (ERDC-CERL, 2014).

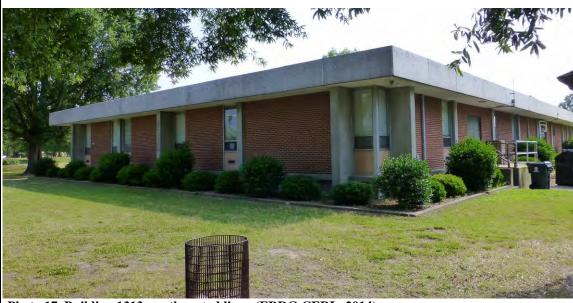
Photo 17. Building 1313, southwest oblique (ERDC-CERL, 2014).

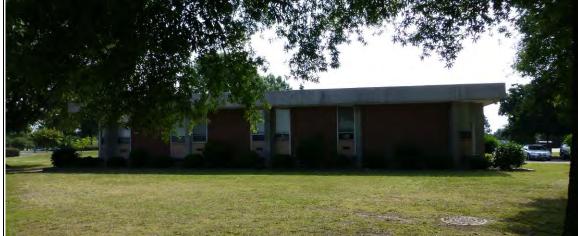
Photo 18. Building 1313, west elevation (ERDC-CERL, 2014).

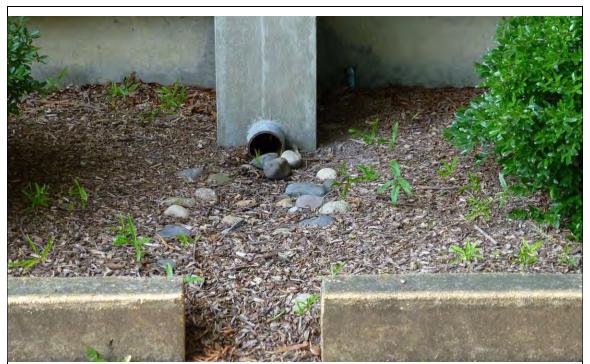
Photo 19. Building 1313, close-up detail of the integrated downspout within the concrete buttress on the north (front) elevation (ERDC-CERL, 2014).

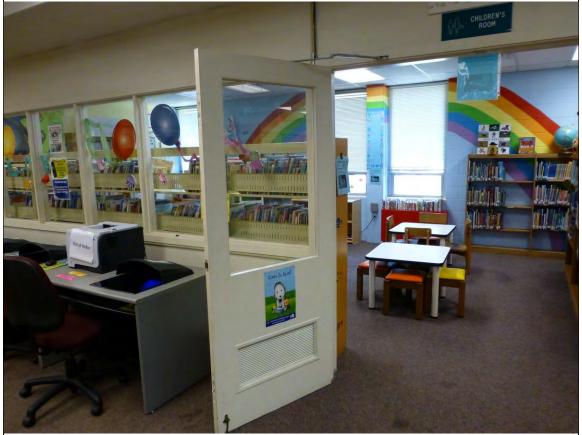
Photo 20. Building 1313, original wall divider and door on library interior (ERDC-CERL, 2014).

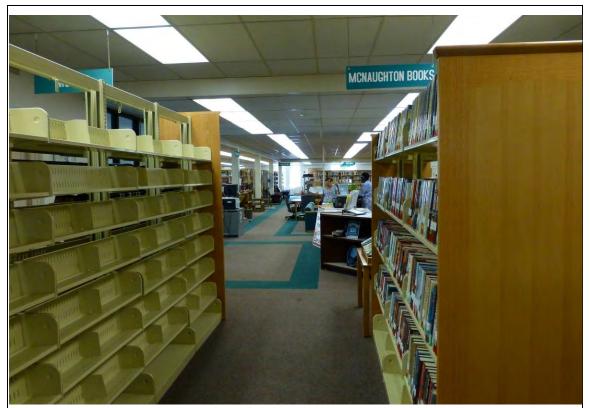
Photo 21. Building 1313, view of overall library interior space, looking east (ERDC-CERL, 2014).

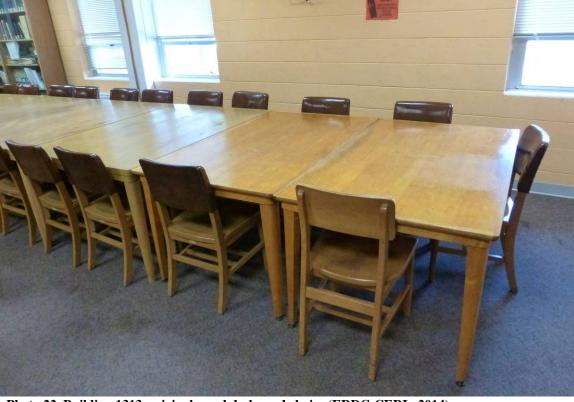
Photo 22. Building 1313, original wood desks and chairs (ERDC-CERL, 2014).

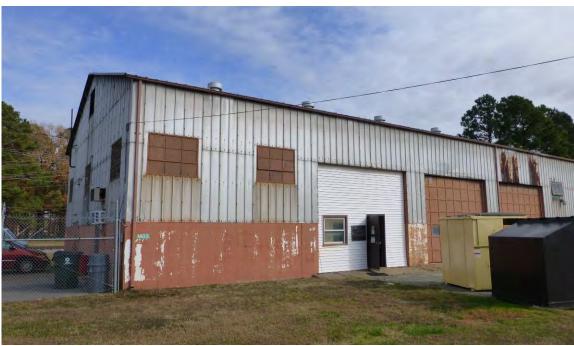
Photo 4. Building 1403, left side of the southwest elevation (ERDC-CERL, 2013).

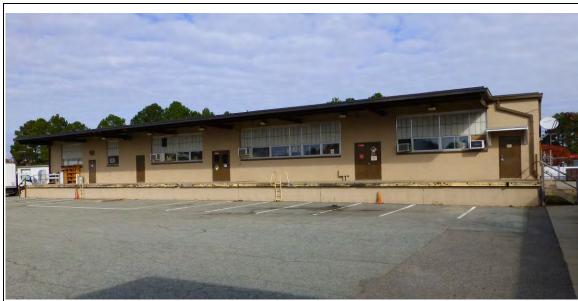
Photo 1. Building 1405, southwest elevation (ERDC-CERL, 2013).

The southwest elevation has a concrete loading dock that stretches across the entire elevation. The loading dock is accessible via two sets of concrete steps. The roof projects over the loading dock, creating a large overhang. There are three single replacement metal doors and two sets of replacement metal doors placed within the concrete block wall. Also under the overhang of the roof are three large groups of replacement windows, a small group of replacement windows, and a single replacement window.

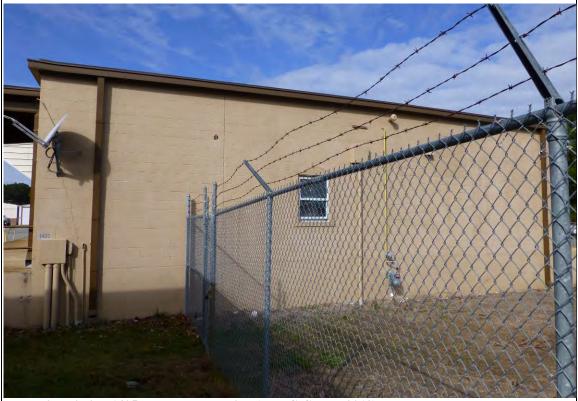
Photo 2. Building 1405, southeast elevation (ERDC-CERL, 2013).

The southeast elevation has one small one-over-one replacement window.

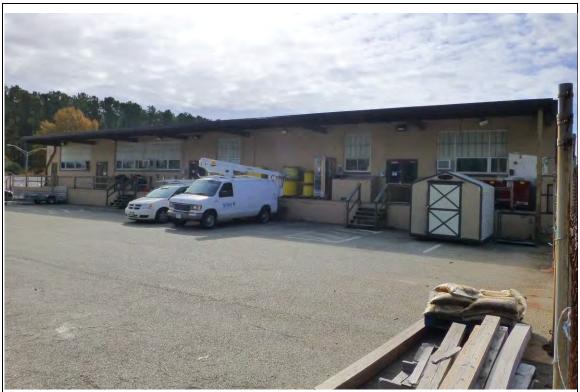
Photo 3. Building 1405, northeast elevation (ERDC-CERL, 2013).

The northeast elevation has a concrete loading dock that stretches across the entire elevation. The loading dock is accessible via a set of concrete steps and three sets of wooden steps. The roof projects over the loading dock, creating a large overhang. There are three sets of metal replacement doors. Also under the overhang is one large group of replacement windows, a small group of replacement windows, and two paired groups of replacement window.

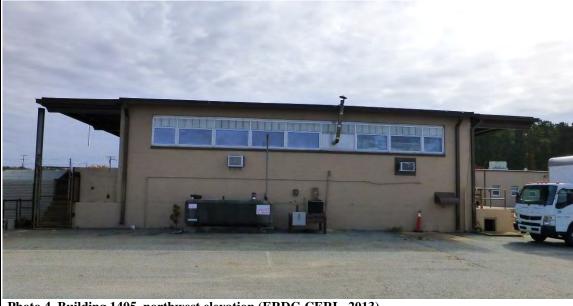
Photo 4. Building 1405, northwest elevation (ERDC-CERL, 2013).

The northwest elevation consists of a band of replacement windows at the top of the concrete block wall.

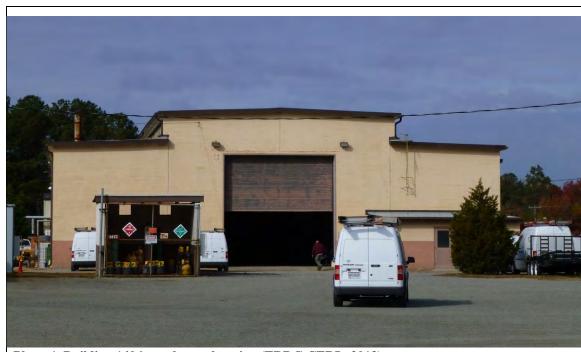
Photo 1. Building 1406, southeast elevation (ERDC-CERL, 2013).

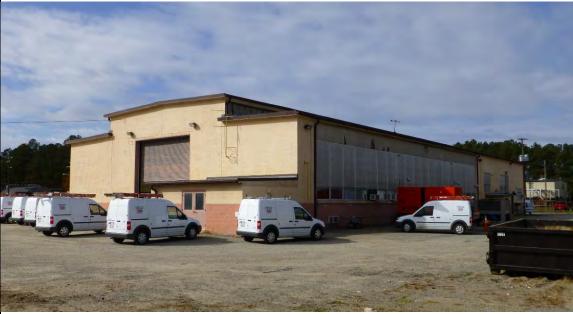
Photo 2. Building 1406, south oblique (ERDC-CERL, 2013).

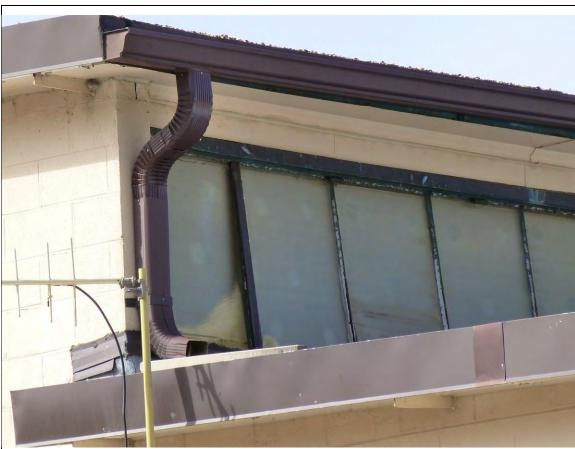
Photo 3. Building 1406, close-up of clerestory windows on the northeast elevation (ERDC-CERL, 2013).

The northeast elevation is dominated by a wall of replacement windows. The windows fill the majority of the elevation, and above these windows is a band of corrugated fiberglass panels. There right side has a paired replacement window, a group of three replacement windows, and a smaller replacement window. A small concrete-block appendage projects off the right side of the elevation. The appendage has both a flat roof and a gable roof and two door openings. The original steel-sash clerestory windows are visible on this elevation.

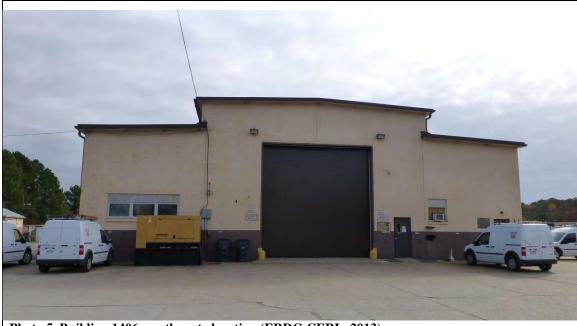
Photo 5. Building 1406, northwest elevation (ERDC-CERL, 2013).

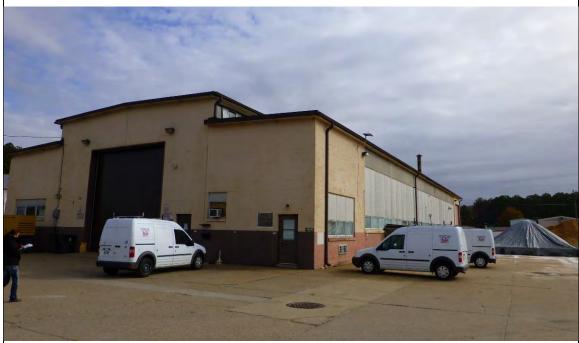
Photo 6. Building 1406, west oblique (ERDC-CERL, 2013).

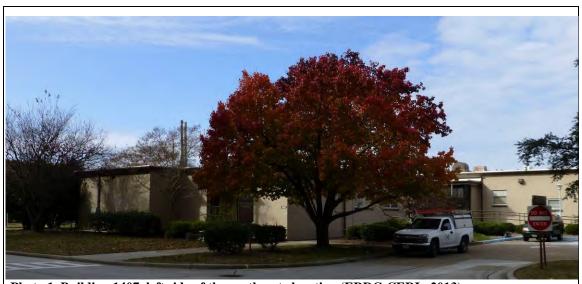
Photo 1. Building 1407, left side of the southeast elevation (ERDC-CERL, 2013).

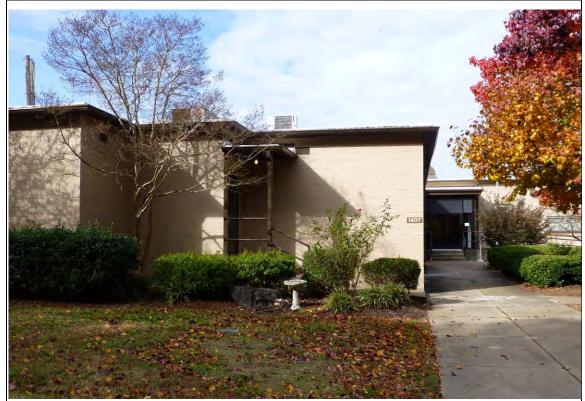
Photo 2. Building 1407, close-up of the left side of the southeast elevation, showing two entries into the building (ERDC-CERL, 2013).

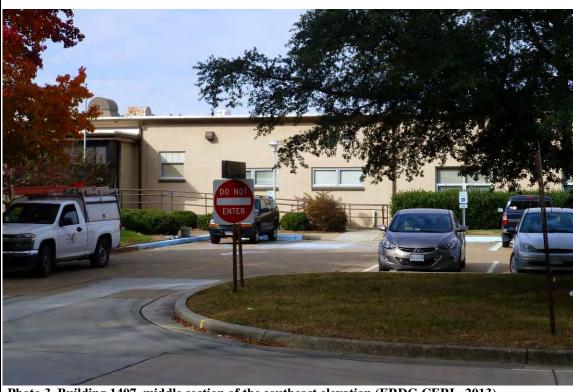
Photo 3. Building 1407, middle section of the southeast elevation (ERDC-CERL, 2013).

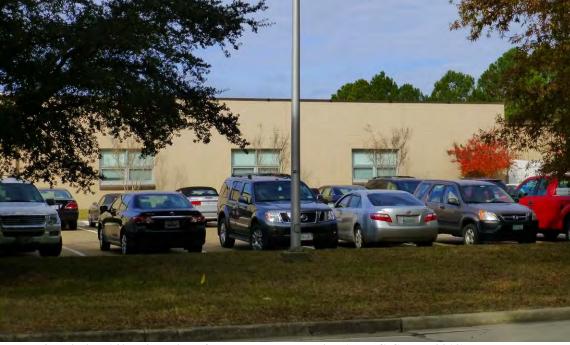
Photo 4. Building 1407, right side of the southeast elevation (ERDC-CERL, 2013).

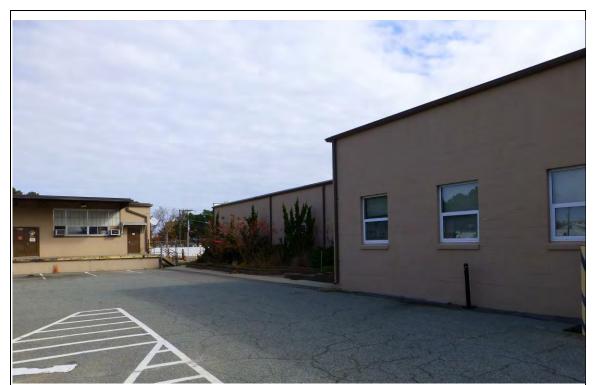
Photo 5. Building 1407, left side of the northwest elevation, looking at the addition (ERDC-CERL, 2013).

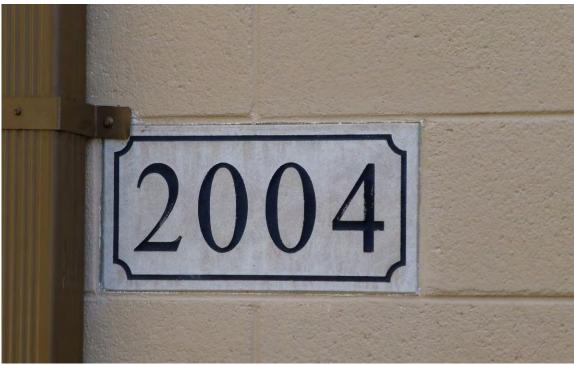
Photo 6. Building 1407, cornerstone for the date of the addition (ERDC-CERL, 2013).

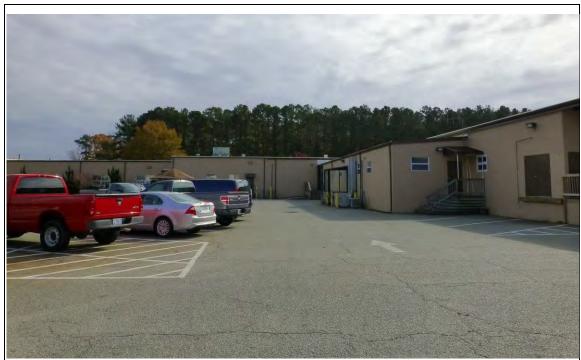
Photo 7. Building 1407, north oblique (back elevation) (ERDC-CERL, 2013).

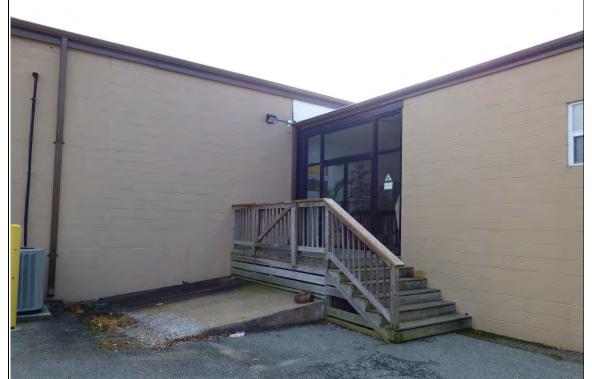
Photo 8. Building 1407, modified entry located at the intersection of the two wings on the north elevation (ERDC-CERL, 2013).

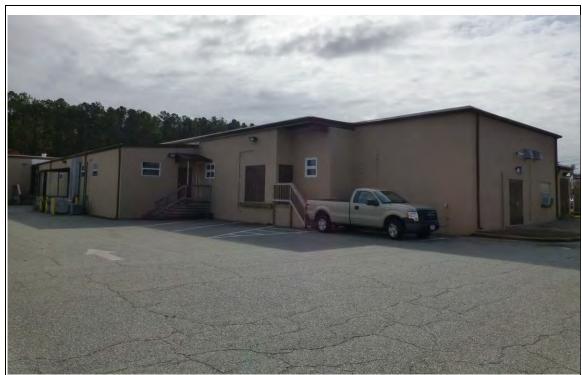
Photo 9. Building 1407, northeast elevation of the southwest wing (ERDC-CERL, 2013).

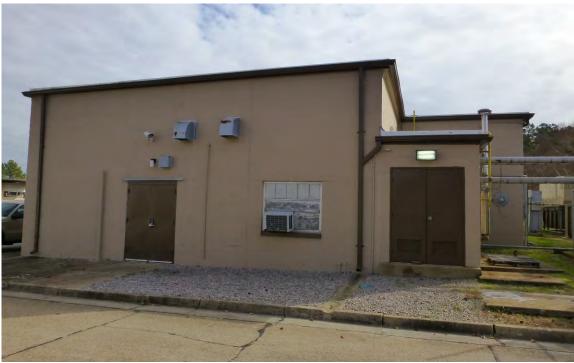
Photo 10. Building 1407, northwest elevation of the southwest wing (ERDC-CERL, 2013).

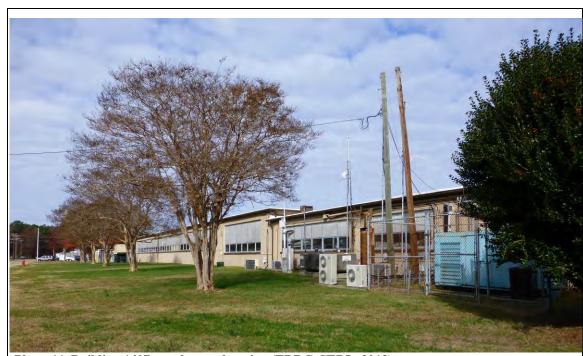
Photo 11. Building 1407, southwest elevation (ERDC-CERL, 2013).

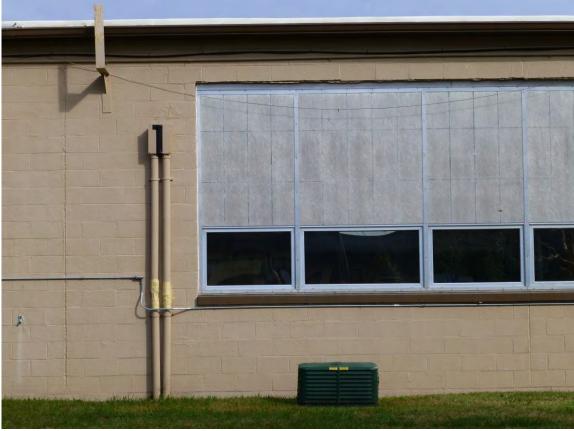
Photo 12. Building 1407, modified windows on the southwest elevation (ERDC-CERL, 2013).

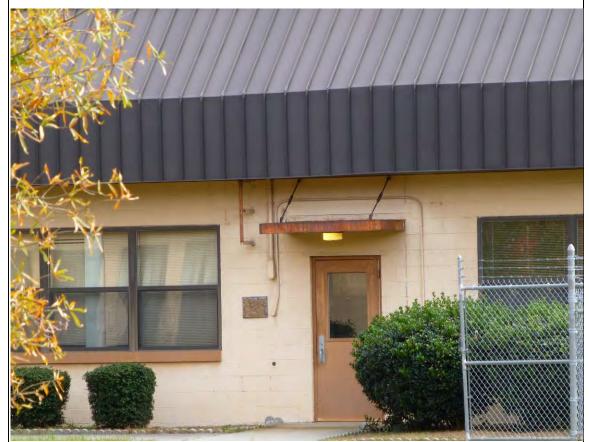
Photo 2. Building 1410, close-up of door and replacement windows on the northwest elevation (ERDC-CERL, 2013).

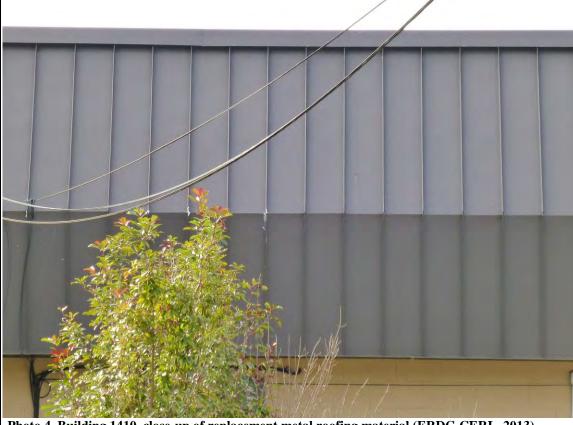
Photo 4. Building 1410, close-up of replacement metal roofing material (ERDC-CERL, 2013).

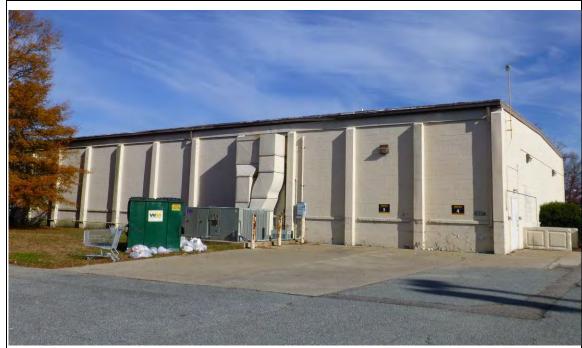
Photo 2. Building 1527, southwest elevation (ERDC-CERL, 2013).

The southwest (back) elevation is divided into fifteen bays by concrete buttresses. There are no door or window openings on this elevation. The exterior walls are concrete block. The raised concrete foundation is visible on this elevation and is called out by a horizontal strip of concrete located between the foundation and the concrete block exterior wall.

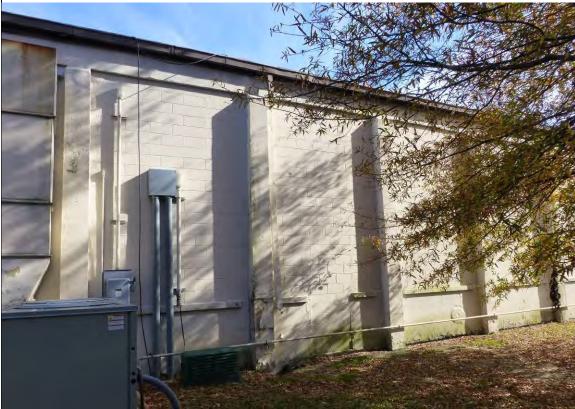
Photo 3. Building 1527, close-up of the southwest elevation (ERDC-CERL, 2013).

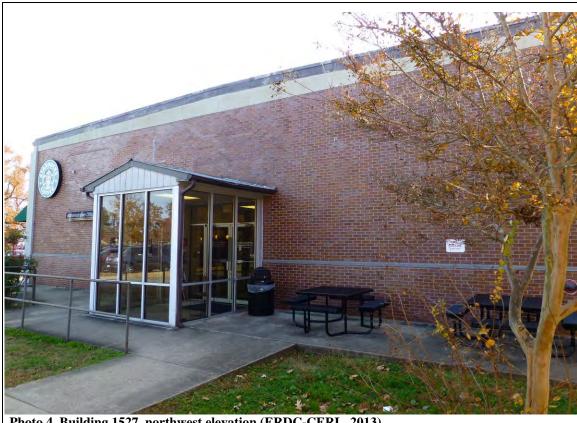
Photo 4. Building 1527, northwest elevation (ERDC-CERL, 2013).

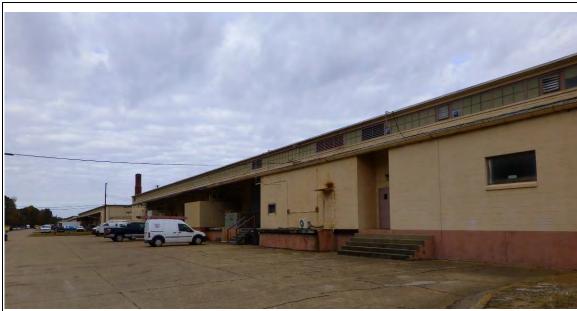
Photo 1. Building 1605, southwest elevation (ERDC-CERL, 2013).

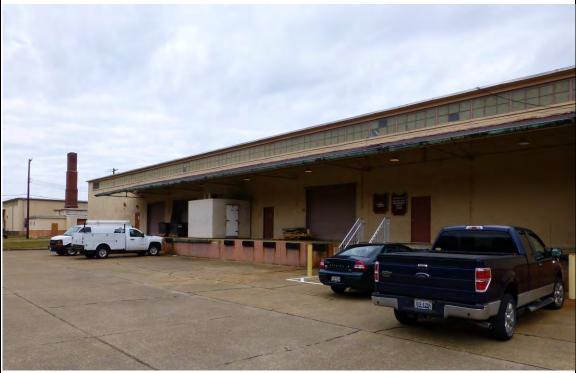
Photo 2. Building 1605. left side of the southwest elevation (ERDC-CERL, 2013).

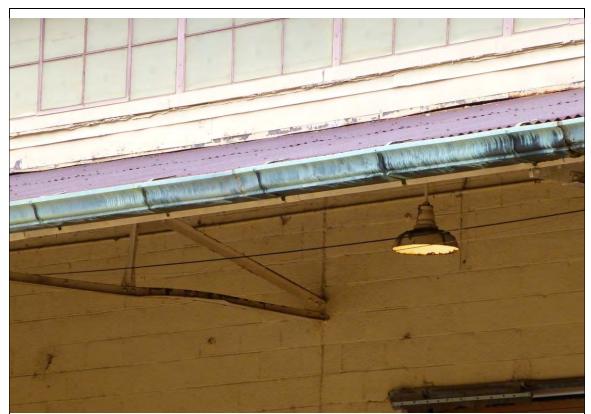
Photo 3. Building 1605, close-up canopy structure, clerestory windows, and light fixture on the southwest elevation (ERDC-CERL, 2013).

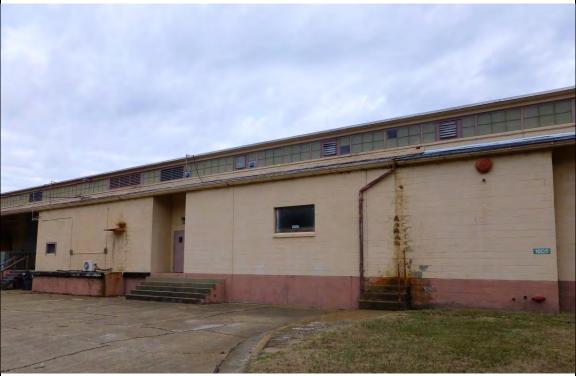
Photo 4. Building 1605, right side of the southwest elevation (might be an infill concrete block wall) (ERDC-CERL, 2013).
